Stent implantation in a left ventricular assist device

Raquel Álvarez Ramos,* Luis María Andrés Lalaguna, and José Luis Díez Gil

Sección de Hemodinámica y Cardiología Intervencionista, Hospital Universitari i Politècnic La Fe, Valencia, Spain

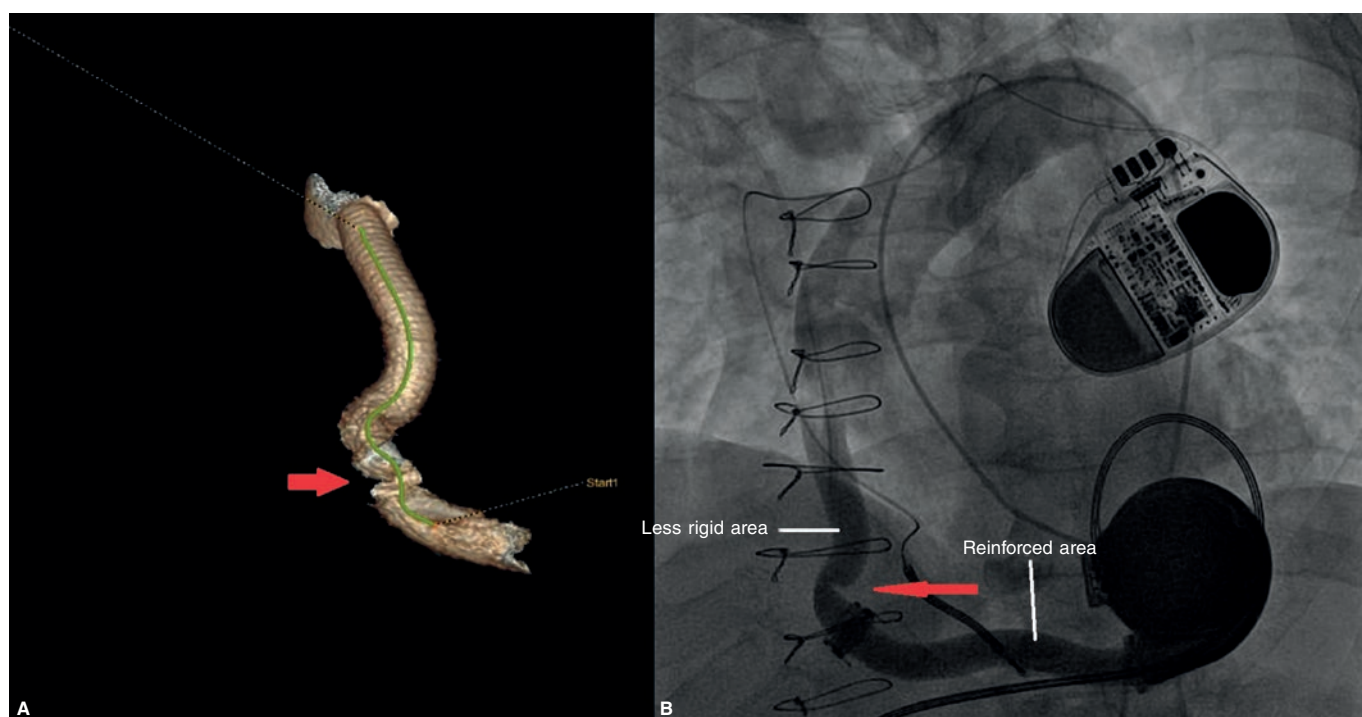
Figure 1.

Sixty-eight-year-old male patient carrier of one HeartWare left ventricular assist device as destination therapy due to ischemic dilated cardiomyopathy. Two years after the implantation, the patient experienced episodes of orthostatic hypotension consistent with low flow alerts of a few seconds duration. He also showed an impaired renal function. On suspicion of device thrombosis one computed tomography angiography was performed that revealed the shortening of the outflow cannula of the pump (figure 1A, arrow).

The interventional cardiology unit was contacted and they performed a ventriculography. The suction of contrast by the pump revealed the existence of kinking of the outflow cannula that was causing a severe stenosis in its mid-section (figure 1B [arrow] and figure 2).

Since the diameter of the cannula was known thanks the specifications established by the manufacturer (10 mm) a 10 x 57 mm BeGraft chrome-cobalt-coated stent was advanced (figure 3A) and deployed in the area of the kinking. Predilatation was performed using a 10 x 30 mm noncompliant balloon with good angiographic results (figure 3B, video 1 of the supplementary data) and normalization of the functioning parameters of the device. The patient had a favorable evolution.
