Making matters worse with Impella

Rizar el rizo en el soporte con Impella

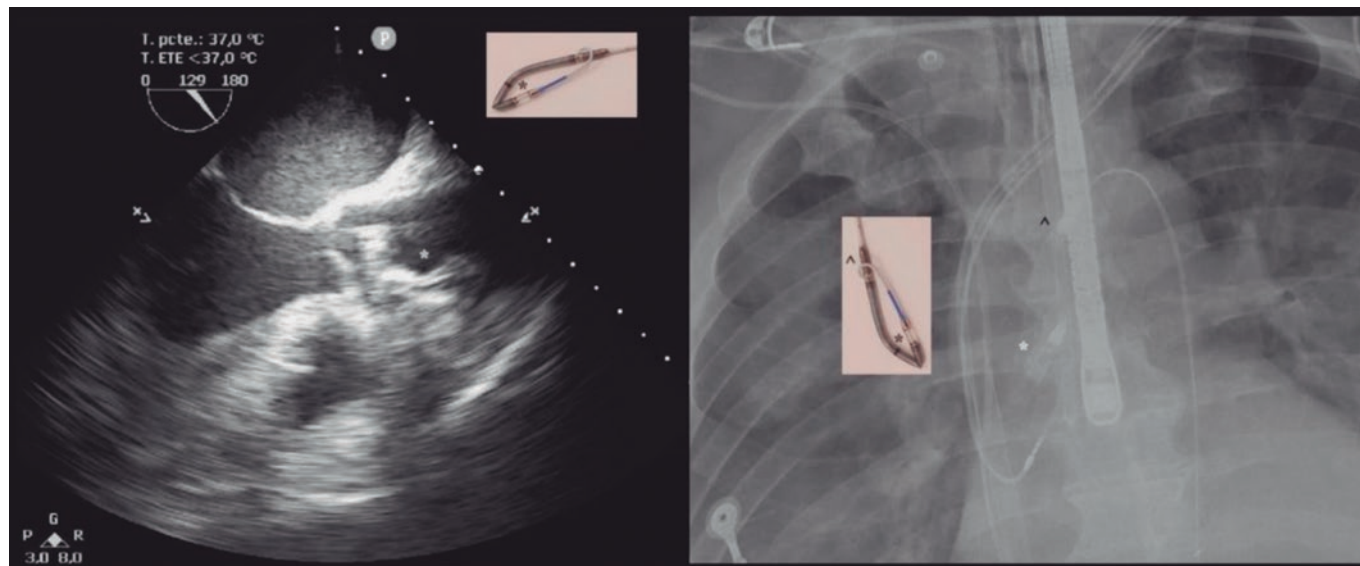
Figure 1.

A 53-year-old man was treated with extracorporeal cardiopulmonary resuscitation with the controlled automated reperfusion of the whole body (CARL) system (Resuscitec, Germany) after a refractory in-hospital cardiac arrest following an arrhythmic storm in the setting of an episode of inflammatory cardiomyopathy. The patient required Impella-CP device implantation (Abiomed, United States) via femoral access due to insufficient unloading with the intra-aortic balloon pump. Catheter malapposition was suspected after several suction alarms were triggered. Despite repeated attempts at repositioning, flow rates remained < 1 L/min. Transesophageal echocardiography and thoracic x-ray (figure 1) confirmed that the catheter had bent in upon itself (asterisk in the figure), and the pigtail had been caught in the outlet (figure 2) following the multiple attempts at repositioning. The catheter migrated toward the descending aorta and urgent removal was decided. An attempt to unscrew the pigtail through femoral manipulation proved unsuccessful (figure 3A and video 1 of the supplementary data). A 7-Fr Amplatz Super-Stiff guidewire (Boston Scientific, United States) was advanced through the Impella loop via left radial access, and traction on the catheter from the femoral access successfully disengaged the pigtail from the outlet (figure 3B). Concurrently, a 12 mm \times 20 mm EN-Snare loop (Merit Medical, United States) was inserted to capture the tip of the pigtail (figure 3C). The guidewire was removed and traction was applied simultaneously to the Impella device and the pigtail tip, which extended the Impella (figure 3D and video 2 of the supplementary data) and allowed its extraction through its introducer. We decided not to restart the device due to the risk of thrombosis in its interior, and chose to remove it using a 14-Fr transaortic pigtail catheter through the Impella access.
