## Making matters worse with Impella

### *Rizar el rizo en el soporte con Impella*

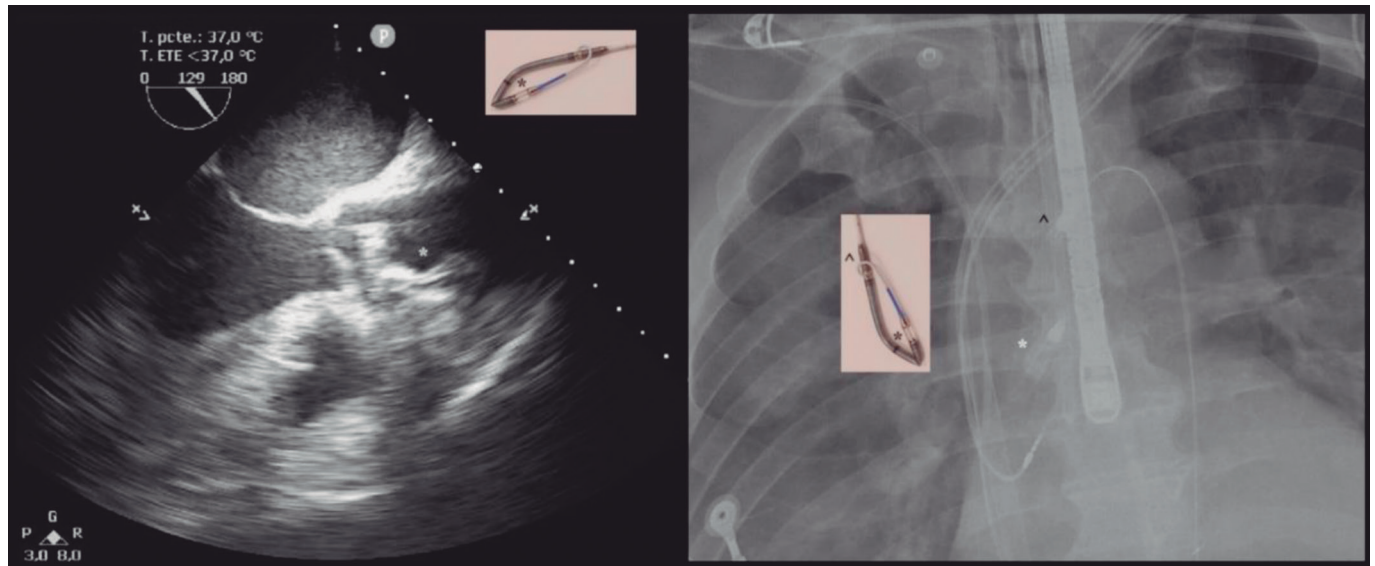
Figure 1.

A 53-year-old man was treated with extracorporeal cardiopulmonary resuscitation with the controlled automated reperfusion of the whole body (CARL) system (Resuscitec, Germany) after a refractory in-hospital cardiac arrest following an arrhythmic storm in the setting of an episode of inflammatory cardiomyopathy. The patient required Impella-CP device implantation (Abiomed, United States) via femoral access due to insufficient unloading with the intra-aortic balloon pump. Catheter malapposition was suspected after several suction alarms were triggered. Despite repeated attempts at repositioning, flow rates remained < 1 L/min. Transesophageal echocardiography and thoracic x-ray (figure 1) confirmed that the catheter had bent in upon itself (asterisk in the figure), and the pigtail had been caught in the outlet (figure 2) following the multiple attempts at repositioning. The catheter migrated toward the descending aorta and urgent removal was decided. An attempt to unscrew the pigtail through femoral manipulation proved unsuccessful (figure 3A and video 1 of the supplementary data). A 7-Fr Amplatz Super-Stiff guidewire (Boston Scientific, United States) was advanced through the Impella loop via left radial access, and traction on the catheter from the femoral access successfully disengaged the pigtail from the outlet (figure 3B). Concurrently, a 12 mm × 20 mm EN-Snare loop (Merit Medical, United States) was inserted to capture the tip of the pigtail (figure 3C). The guidewire was removed and traction was applied simultaneously to the Impella device and the pigtail tip, which extended the Impella (figure 3D and video 2 of the supplementary data) and allowed its extraction through its introducer. We decided not to restart the device due to the risk of thrombosis in its interior, and chose to remove it using a 14-Fr transaortic pigtail catheter through the Impella access.
